# Sharing the Heritage of the Wish Tower

The History, Significance and Conservation  
of Martello Tower 73, Eastbourne

Revision 1  
May 2017

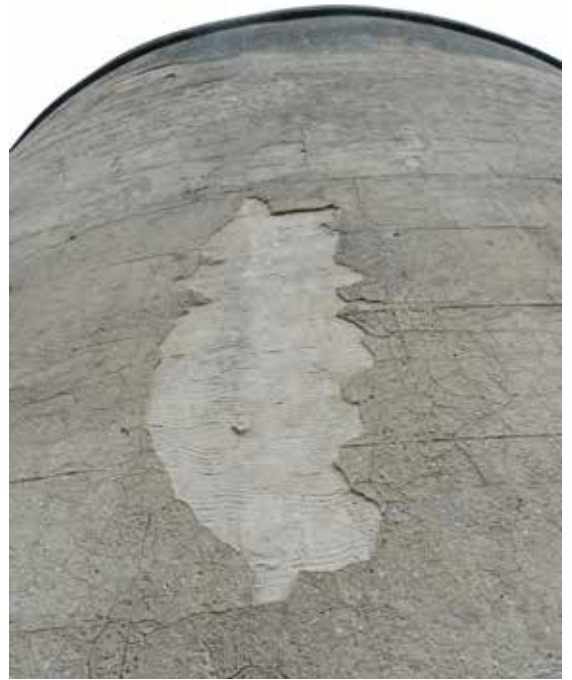
The replacement of stucco render with cementitious render is most definitely to the detriment of The Tower an historical context but also from the very present problem that it is exacerbating the damp in The Tower which is causing slow but inexorable decay to the reproduction floor.

From top: current condition of cementitious render to exterior of the Wish Tower; spalling of bricks in The Moat Wall due to pointing repairs with inappropriate mortar.

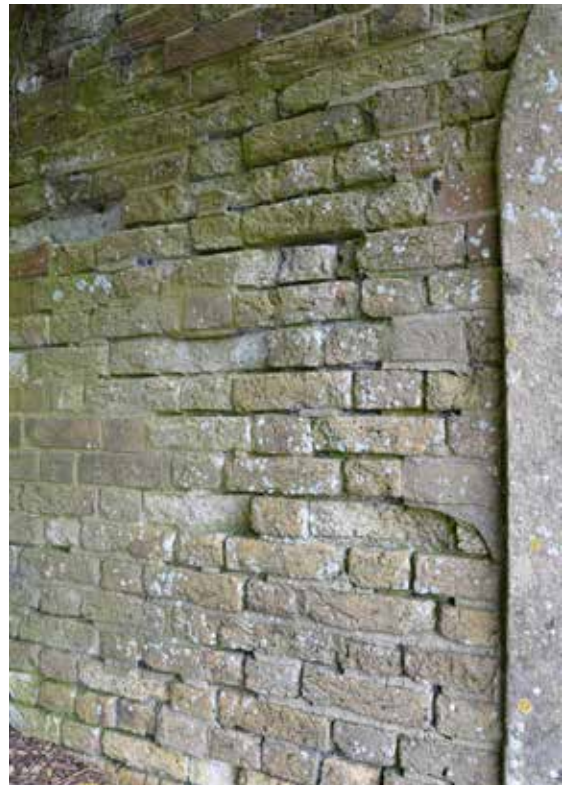
Similarly, the use of cementitious mortars when repairing The Moat Wall has caused additional damage by spalling.

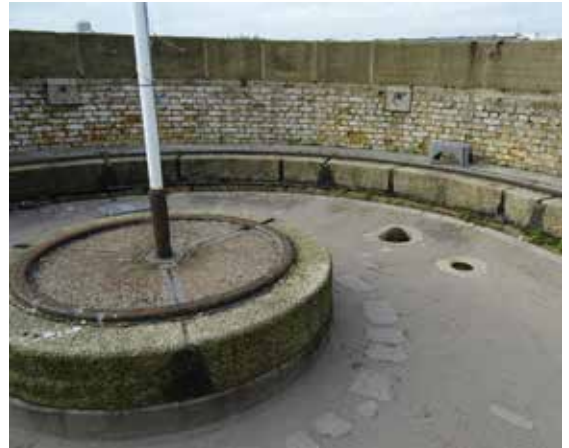
The report suggests that some aspects of the structure and its condition would benefit from further investigation. Nevertheless, the findings are clear that the major problems are water ingress to The Tower through damaged and poorly maintained roof fabric, and use of inappropriate materials in previous repairs to both tower and Moat Wall fabric.

From top: Gun platform showing damaged asphalt; detail of cracked asphalt and failing mortar joint; buckets catching the resulting water ingress.

Clearly, the most important work which would allow continued and, hopefully much increased, use of The Tower is to arrest the ingress of water as a matter of some urgency.

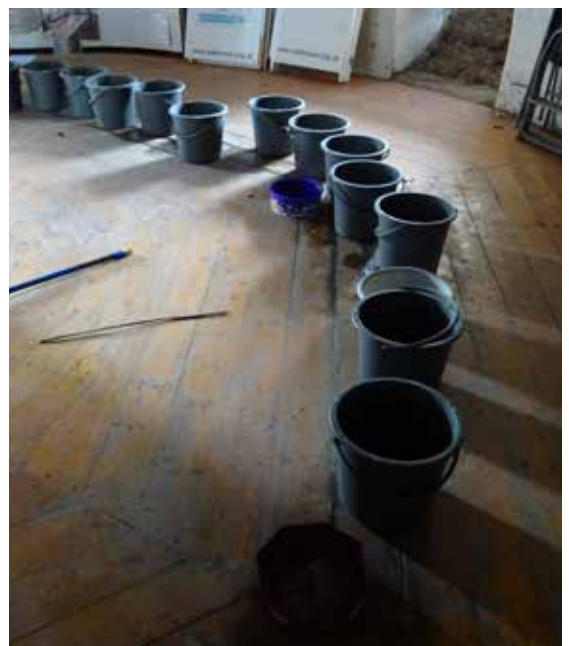
The problem most likely to impact current and any planned future uses of The Tower is the degradation of the wooden floor which is starting to show signs of wet rot due to the continued contact with water. We estimate that something approaching 6 – 9 litres of water a week is being caught in buckets during the winter months.

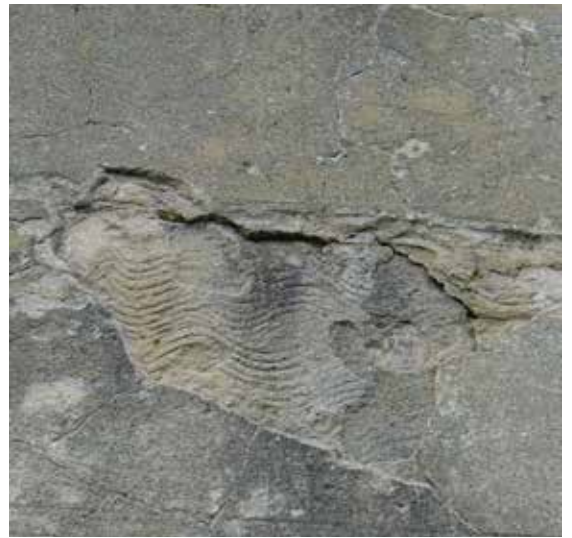
From top: detail of delaminating cementitious render; plant ingrowth to The Moat Wall; garish paint finishes; original copper clad door frame

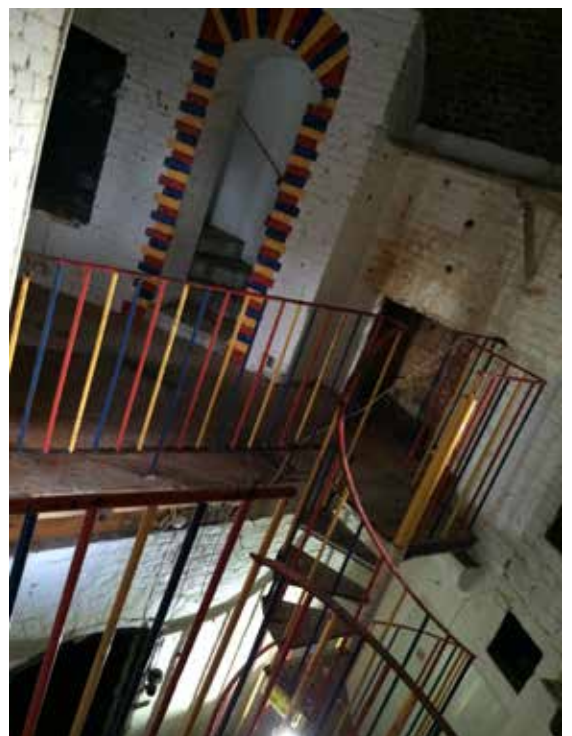
The two modern spiral staircases have been damaged by long exposure to damp and although one is in usable condition the presence of brightly-coloured paint (of unknown type) is detrimental to the appearance of The Tower and feels very distracting.

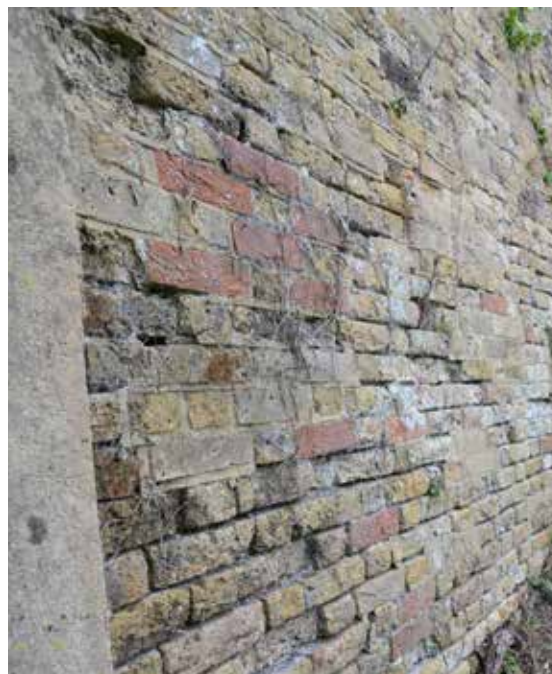
From top: ceiling block and tackle (reproduction but of appropriate style); damaged Moat Wall brick around archway to sea front.

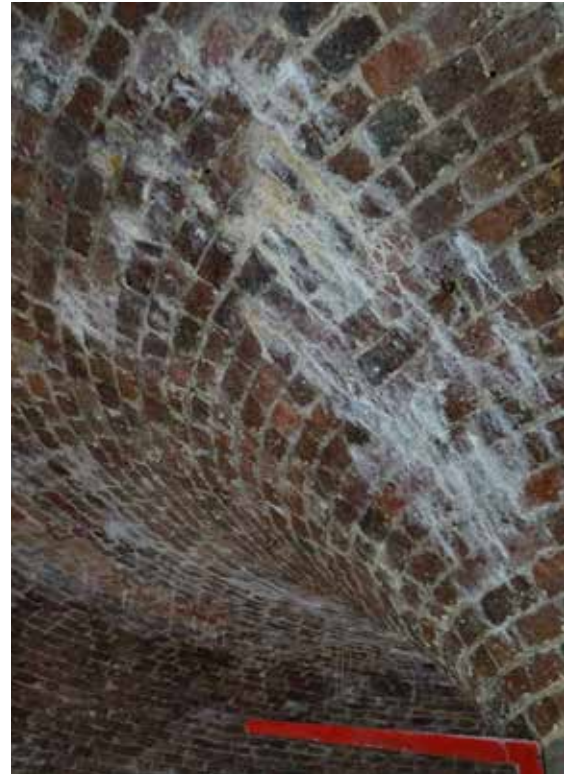
From top: water damage to brick roof arch and C20 intrusion from puppet museum; tower as visitor attraction with rudimentary temporary signage.

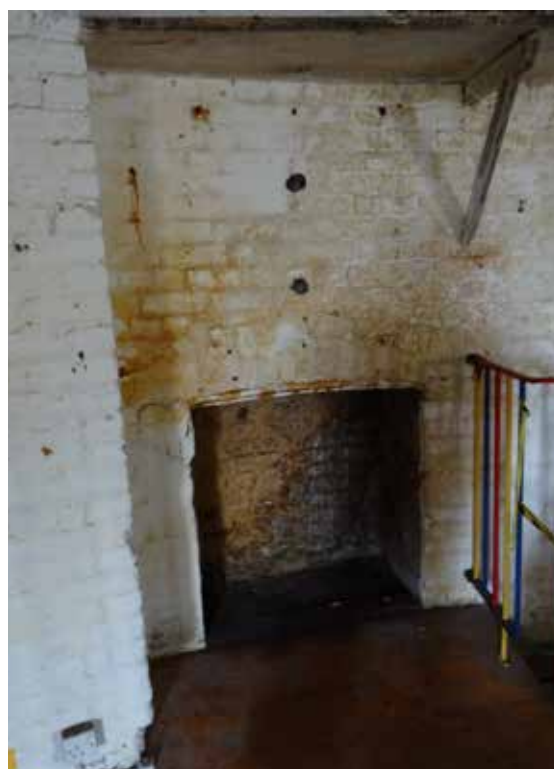
From top: Cracks to the coping of the parapet wall; brick damage and greenery infiltrating brickwork; stalactites from water ingress; damp to fireplace.

Replacement of current cementitious render with lime render of appropriate formulation	£105,000
Replacement of asphalt roof covering with new asphalt covering with improved upstand and detailing	£25,000
Inner wall surfaces remove paint and repair damaged bricks and pointing	£12,000
Remove render on parapet coping, repair stone and reinstate chimneys for ventilation	£11,000
Repair damaged bricks and pointing on parapet wall	£7,000
Repair internal damaged brickwork	£5,000
<b>Approximate total cost of this block of repairs</b>	<b>£165,000</b>

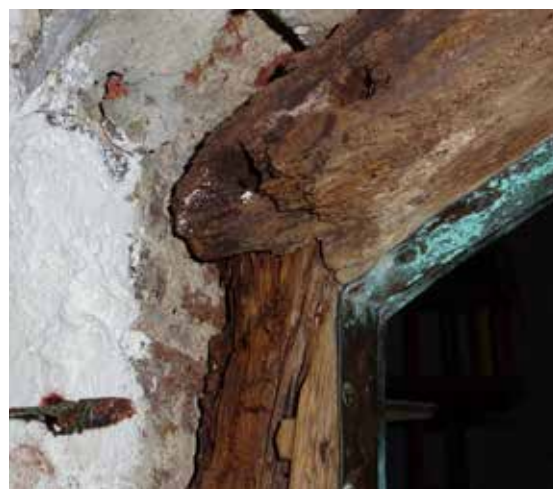
From top: extensive greenery infiltrating Moat Wall; ventilation shaft suspected to be blocked; rotten door surround in magazine/powder room; damp damage to spiral staircase (disused).

Remove plant ingrowth, repoint with appropriate materials, cut out and replace eroded bricks using appropriate materials, reform cobbled wall capping	£52,000
Assess ventilation shafts, drainage pipes and flue with CCTV survey	£1,000
Repair door frame to magazine, reuse existing copper cladding	£1,200
<b>Approximate total cost of this block of repairs</b>	<b>£54,200</b>

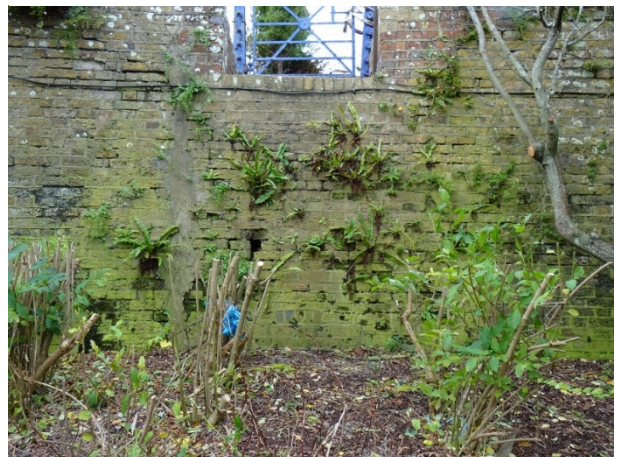
*South (internal) face of northern glacis wall showing brickwork erosion*

6.03 There is currently no concern with the overall structural stability of the retaining wall but its brickwork is suffering as a result of long-term erosion, particularly on its inside face, due to salts being washed through the wall and frost action, which has been hastened by the past use of cement based mortar pointing. This is far too hard for the relatively soft bricks that were originally laid in a lime mortar. There is further discussion on lime mortars/renders in relation to the external wall of the Tower but essentially, the use of hard cementitious mortar will prevent moisture from evaporating through the brickwork joints, trapping it within the bricks themselves, which will remain constantly damp and more susceptible to frost and salt erosion. The bricks were originally laid in lime mortar, which largely remains intact behind the cementitious pointing.

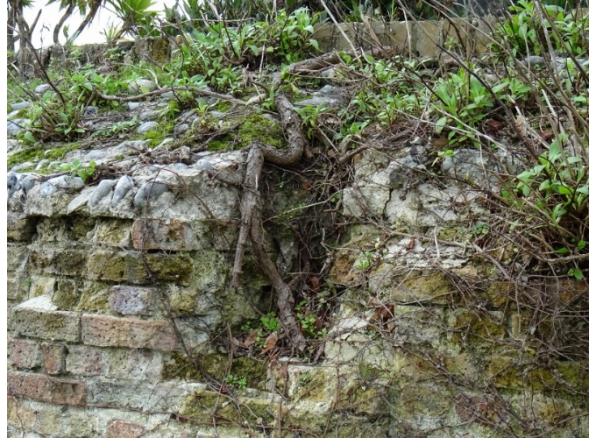
*Cobbled capping to glacis wall*

6.04 There is a full brick on edge coping on top of the inside face of the wall and behind that, the top of the wall batters downwards, where it was originally below ground level. The now exposed outside top edge of the wall has been capped with cobbles from the beach. The capping is in a poor condition, being badly cracked with much vegetation growing into it. Water soaking into the top of the wall will be adding to its deterioration.

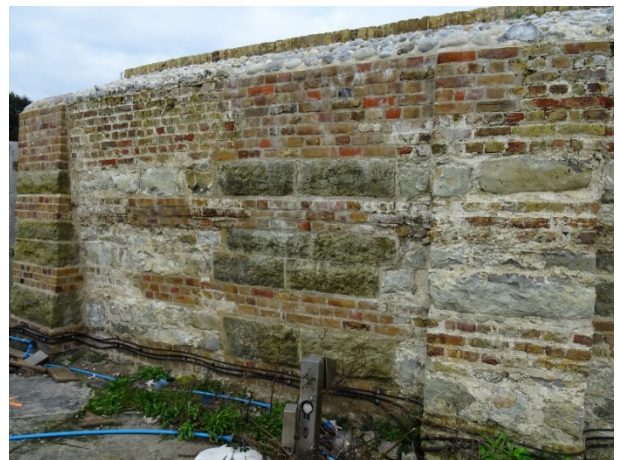
*Previously repaired section of glacis wall at south-west end*

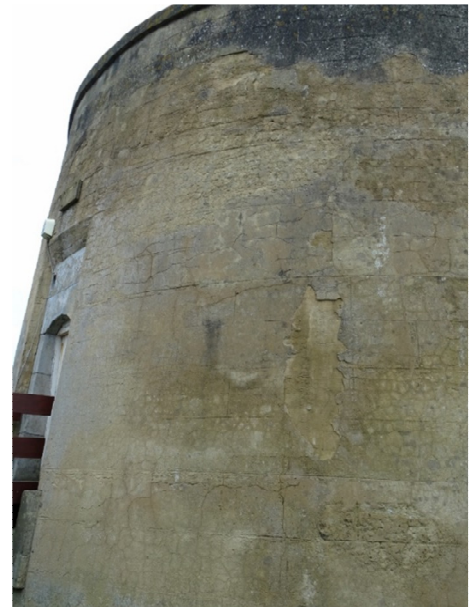
*Condition of render from the north-west*

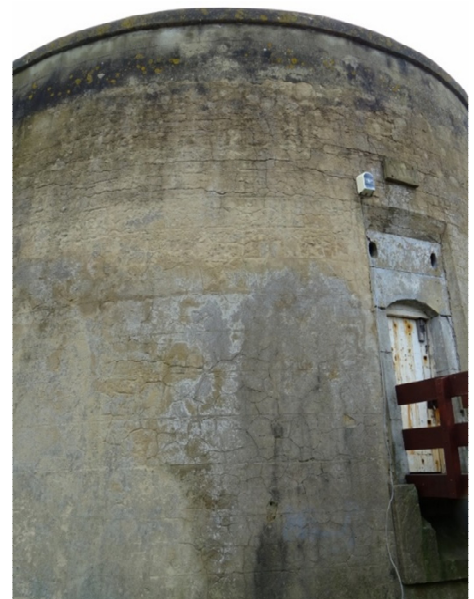
*Condition of render from the north-east*

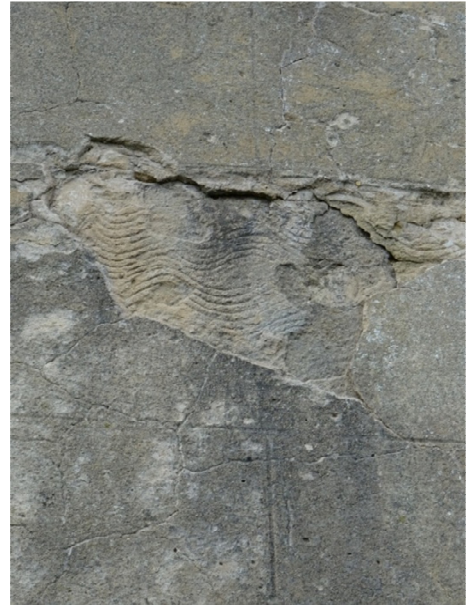
*Condition of render from the south-east*

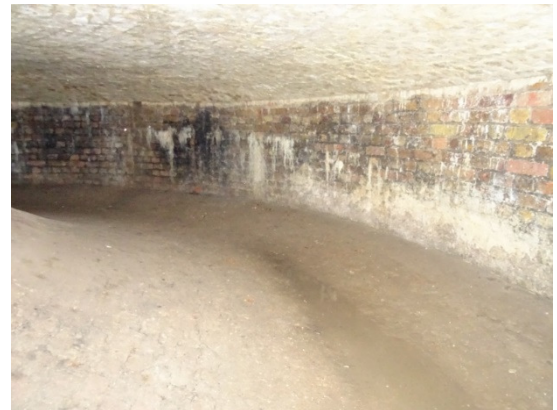
6.19 The brickwork forming the cistern vaulting is in a remarkably good condition, as is the brickwork forming its perimeter wall. No structural repairs are considered necessary within the cistern.

*Cistern vaulting*

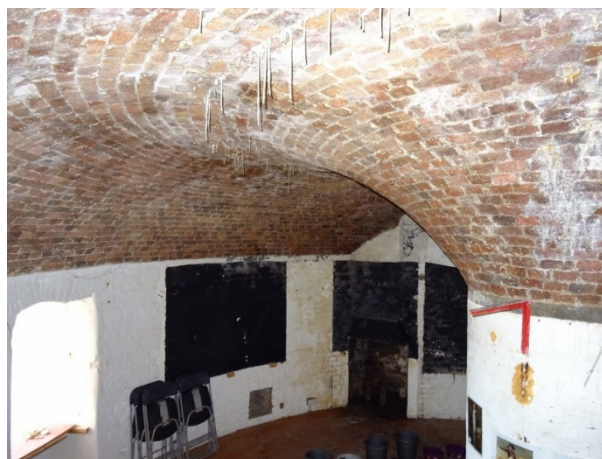
*Roof vaulting to accommodation level towards the east. Note stalactites*

6.28 As with the fabric elsewhere, the obvious defect affecting this level is one of water ingress, particularly through the roof vaulting.

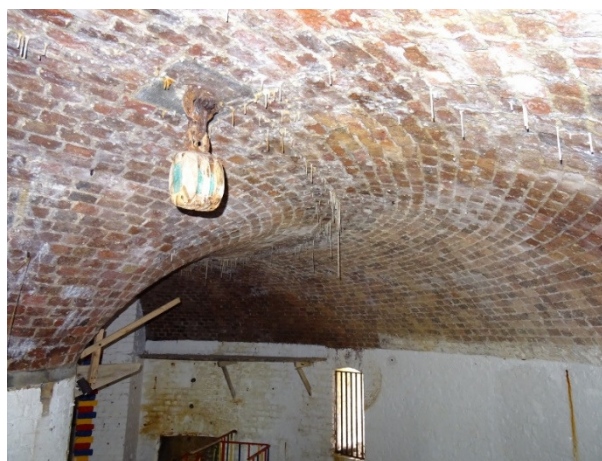
*Roof vaulting with stalactites*

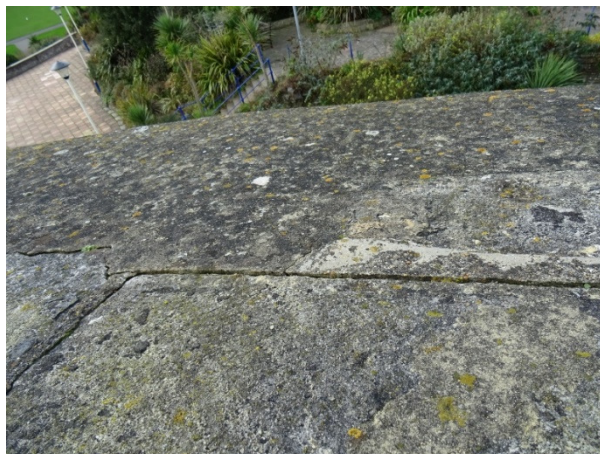
*Cracking to parapet render/stone*

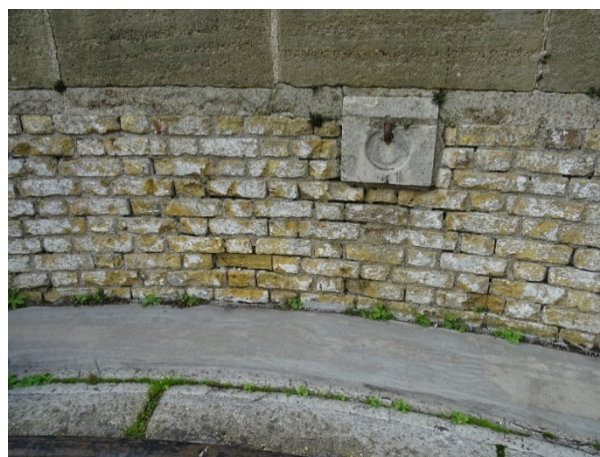
*Damaged parapet brickwork*

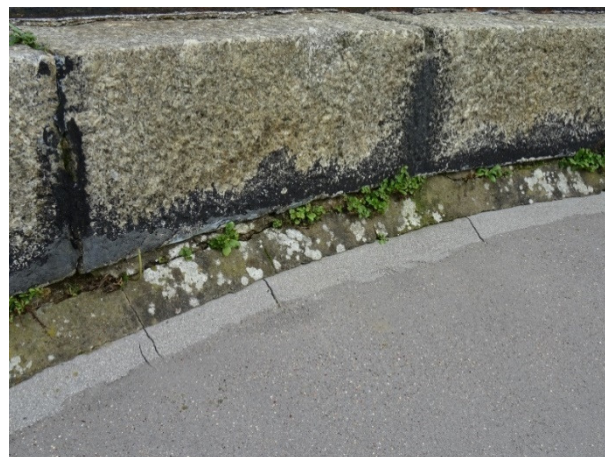
*Poor upstand skirt and cement fillet to asphalt*
