# Sharing the Heritage of the Wish Tower

The History, Significance and Conservation  
of Martello Tower 73, Eastbourne

Revision 1  
May 2017

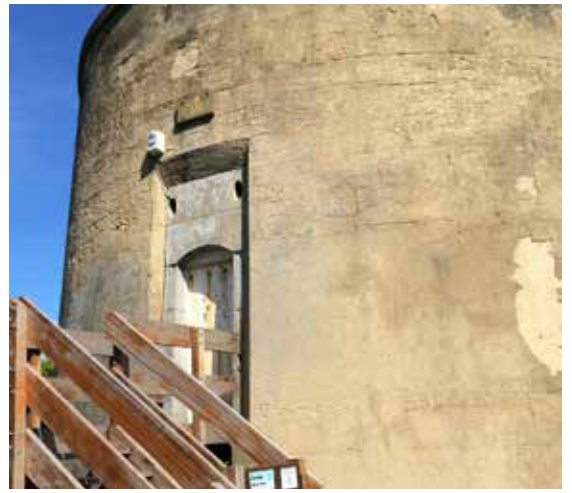
From top: exterior view of Wish Tower door; internal supporting pillar & arched roof; magazine/powder room; under-basement cistern with inverted arch.

Front door – a substantial, cross-boarded door with strap and pintle hinges gives every appearance of being original, albeit with a number of fairly aggressive 20th century intrusions and clumsy repairs.

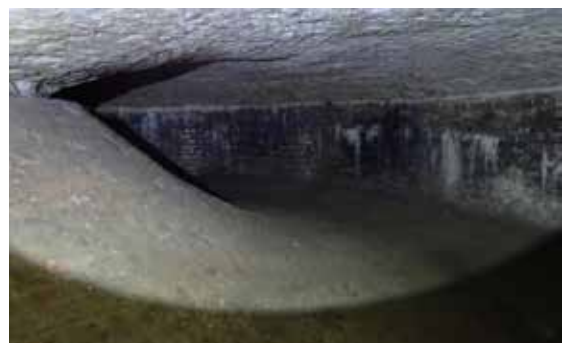
Sub-basement cistern - this is in good condition and clearly shows the construction and appears to have more waterproof mortar to better hold water in the area. It is also relatively simple to gain safe access to the cistern to appreciate the construction. It is considered to be of high significance.

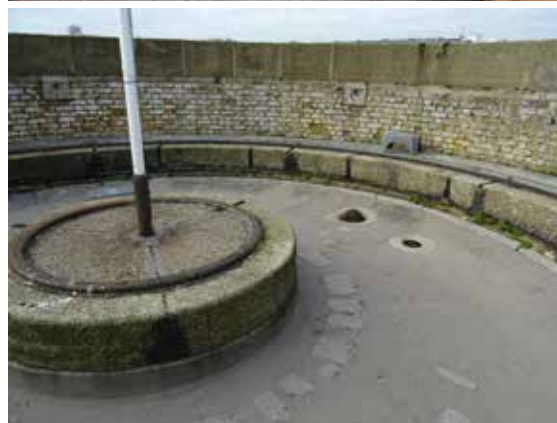
The roof area also contains a number of vents and drainage holes, some of which have been closed over in an attempt to prevent water ingress. At least one of the drainage holes appears to communicate with a downpipe which runs down the inside of The Tower's wall slightly to the east of the front door and running vertically down towards the basement level. As things stand, this pipe is currently diverted out through the wall close to the current ground level but may have been originally designed to fill the cistern, although the evidence of this in the cistern is not conclusive.

From top: access hatchway to gun platform; gun platform showing damaged asphalt; gun rail with drainage channel; examining roof vents.

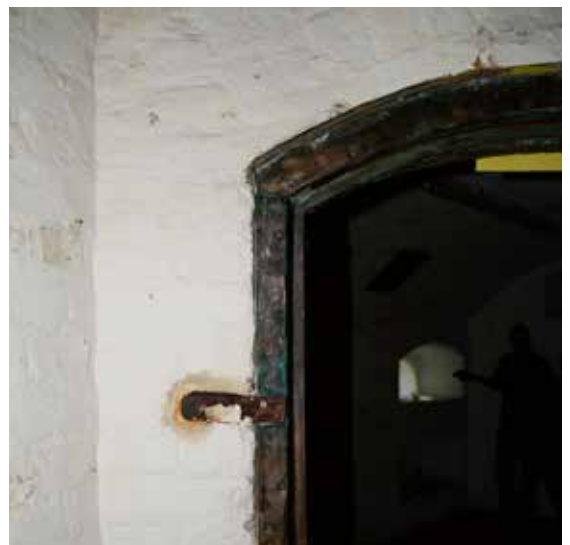
Doorway to the magazine - whilst very damaged by wood rot to the original timbers, it is clad with the original anti-sparking copper sheet and nails. This aids the interpretation of the space not only with regards to construction but engineering and science backgrounds.

From top: Tower 25 in Dymchurch (not open to the public); interior arched roof (unmodified); copper cladding to the frame of the doorway of the magazine/powder room (unmodified)

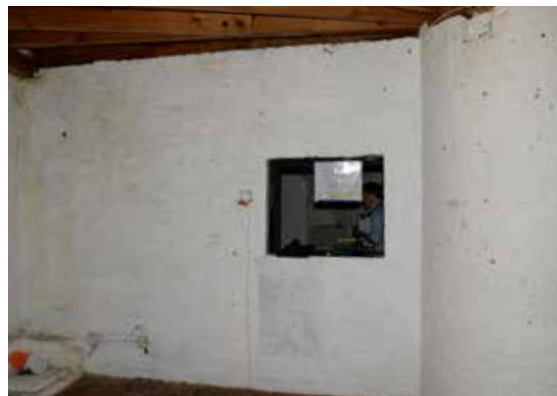
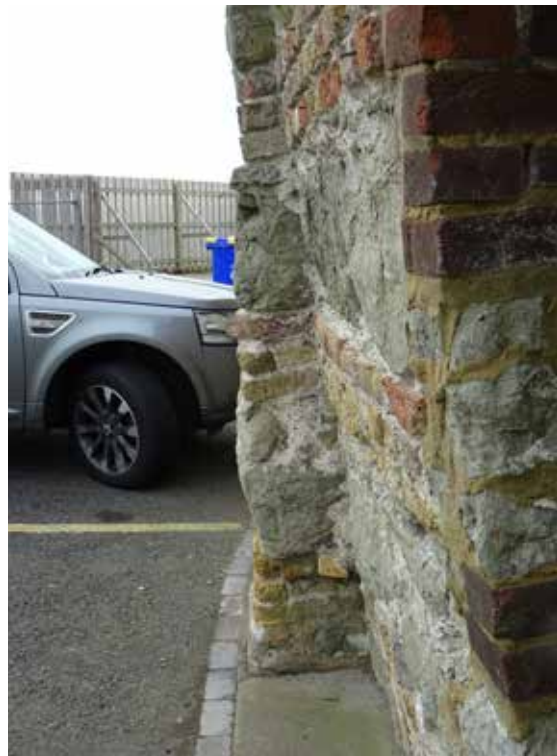
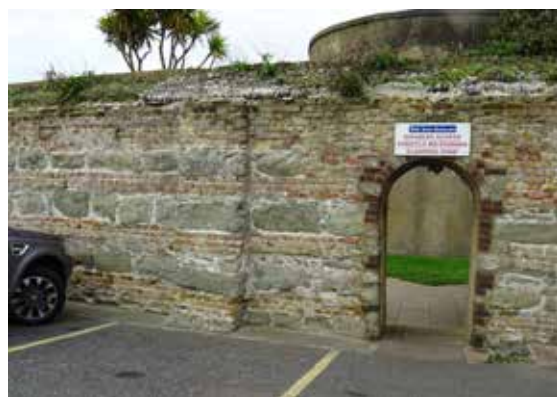
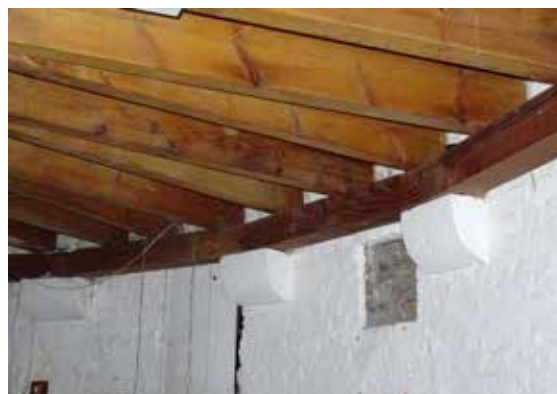
From top: enlarged powder room window in basement; revealed Moat Wall construction on the seaward side; Moat Wall showing courses of brick and greensand on the seaward side; suspended floor structure

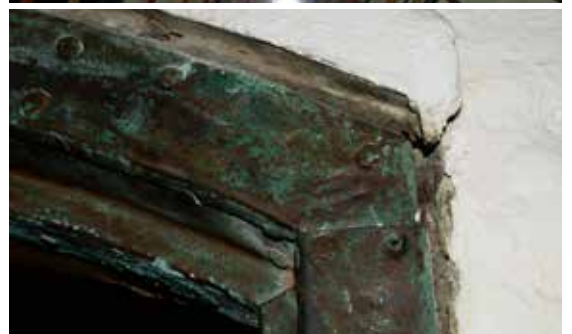
From top: detail of delaminating cementitious render; plant ingrowth to The Moat Wall; garish paint finishes; original copper clad door frame

Remove plant ingrowth, repoint with appropriate materials, cut out and replace eroded bricks using appropriate materials, reform cobbled wall capping	£52,000
Assess ventilation shafts, drainage pipes and flue with CCTV survey	£1,000
Repair door frame to magazine, reuse existing copper cladding	£1,200
<b>Approximate total cost of this block of repairs</b>	<b>£54,200</b>

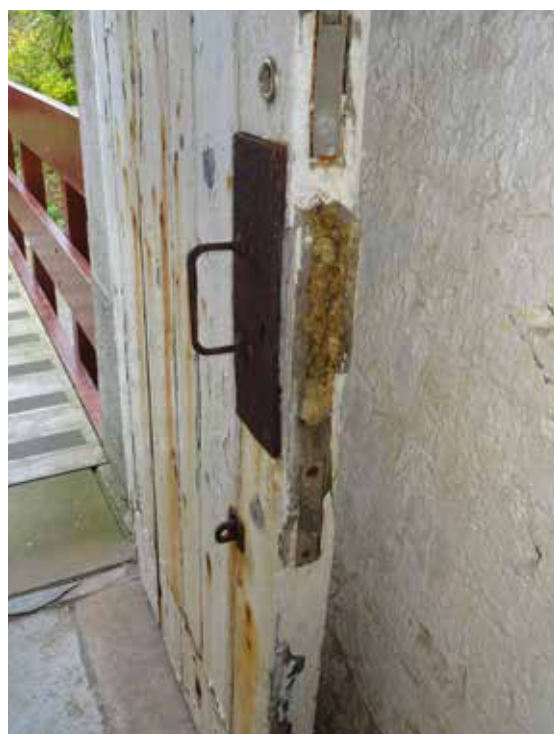
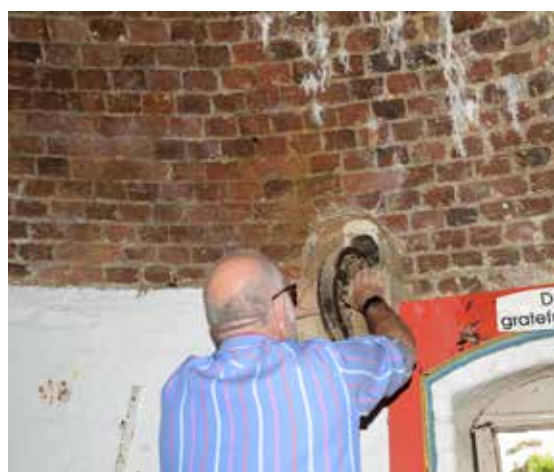
From top: Tours are probably the best form of interpretation but signage is helpful when The Tower is closed; front door showing many alterations; assessing the condition of the drawbridge pulley.

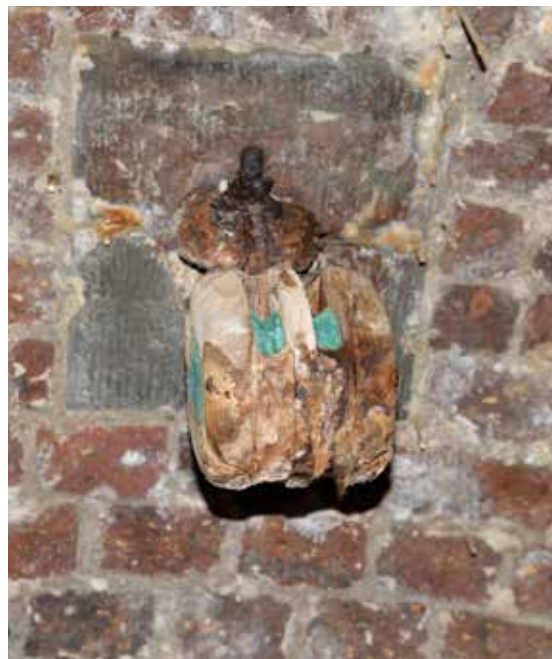
From top: ceiling block and tackle (reproduction but of appropriate style); damaged Moat Wall brick around archway to sea front.

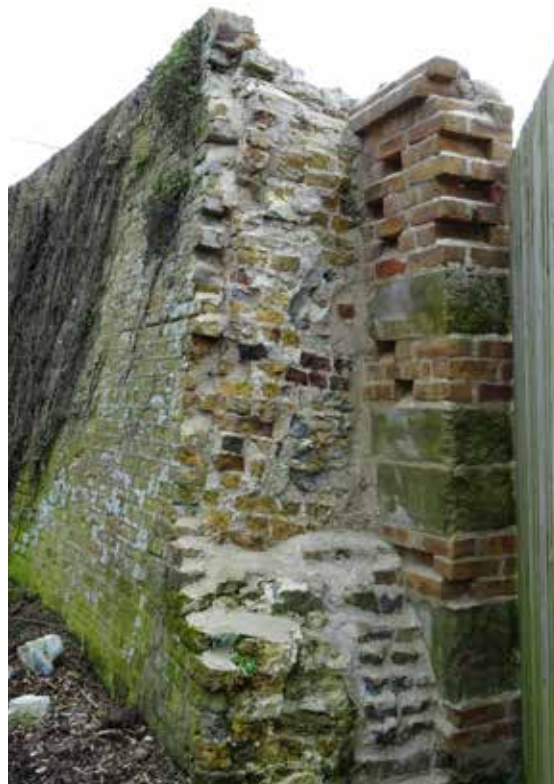
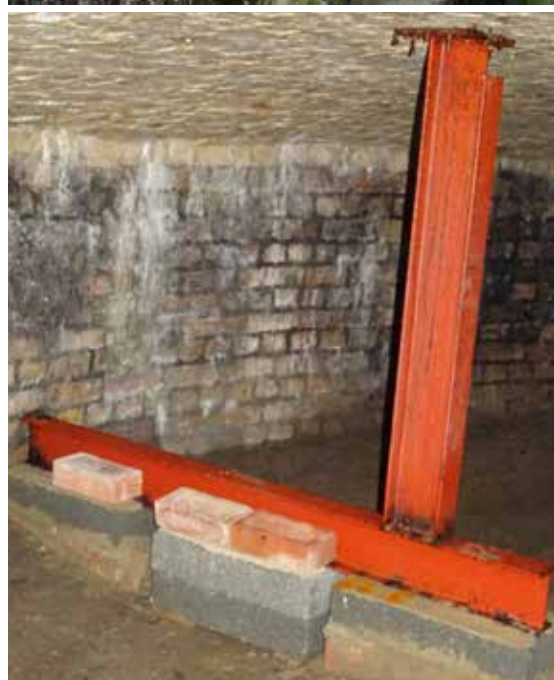
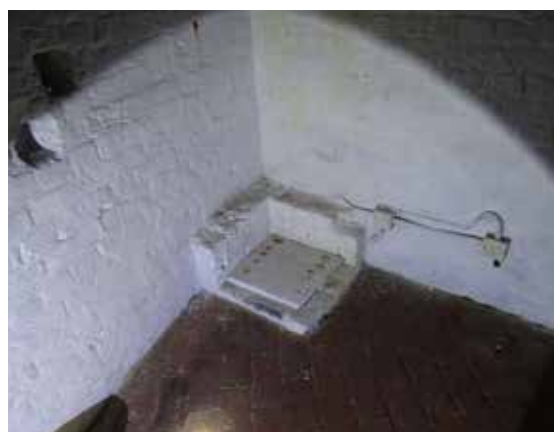
From top: Section through Moat Wall where it was removed which illustrates construction; steel insertion in basement to support spiral staircase; sump of unknown purpose in basement, and intrusion of C20 electrical wiring.

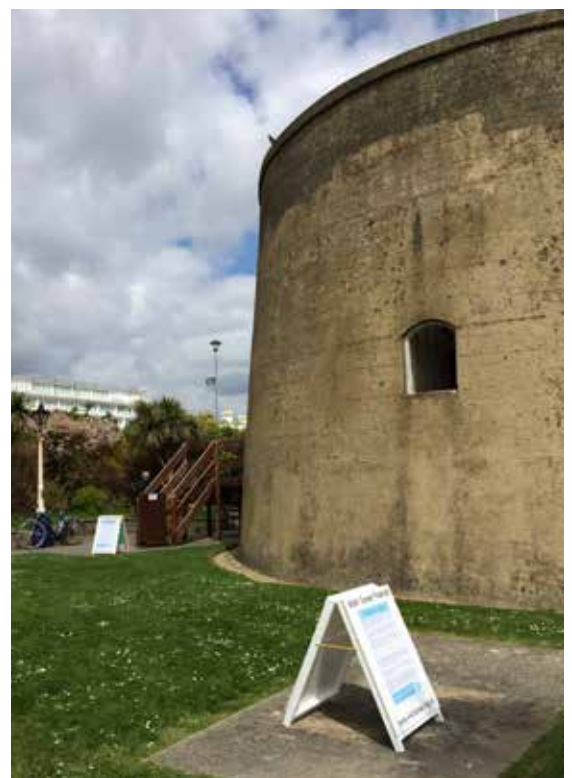
From top: water damage to brick roof arch and C20 intrusion from puppet museum; tower as visitor attraction with rudimentary temporary signage.

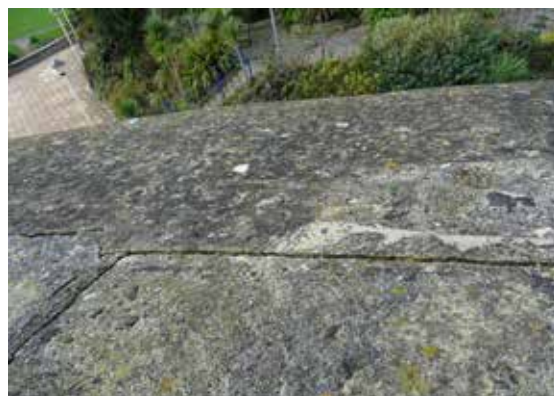
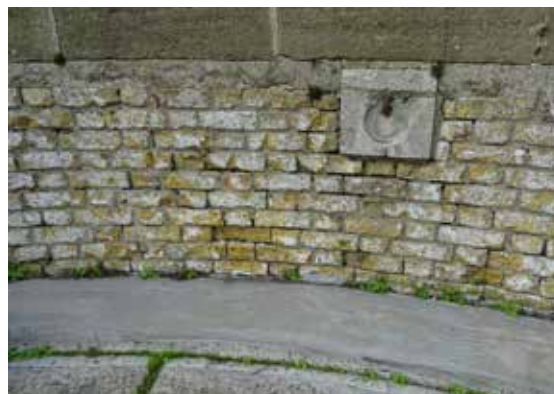
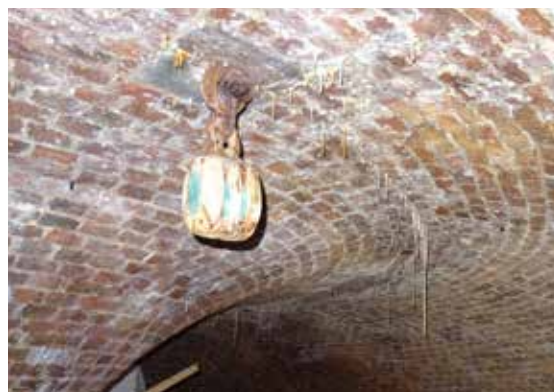
From top: Cracks to the coping of the parapet wall; brick damage and greenery infiltrating brickwork; stalactites from water ingress; damp to fireplace.

Replacement of current cementitious render with lime render of appropriate formulation	£105,000
Replacement of asphalt roof covering with new asphalt covering with improved upstand and detailing	£25,000
Inner wall surfaces remove paint and repair damaged bricks and pointing	£12,000
Remove render on parapet coping, repair stone and reinstate chimneys for ventilation	£11,000
Repair damaged bricks and pointing on parapet wall	£7,000
Repair internal damaged brickwork	£5,000
<b>Approximate total cost of this block of repairs</b>	<b>£165,000</b>

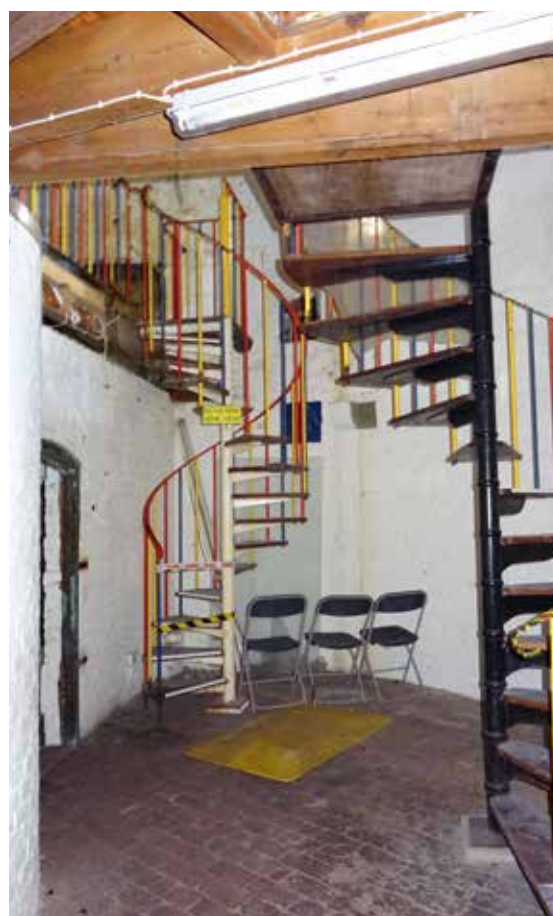
From top: magazine/powder room floor showing original joist position; hatchway to roof which requires additional weatherproofing; brightly painted spiral staircases and C20th electrical intrusions.

Finally there are a number of small jobs that will need to be priced and considered in order to make the job complete: removing 20th century intrusions, repair or replacement of number tablet over the front door, improved weatherproofing of the roof hatch. We have not yet estimated the costs of these but it seems likely that, subject to the required approvals, this might be something the Wish Tower Friends could commission in small pieces.

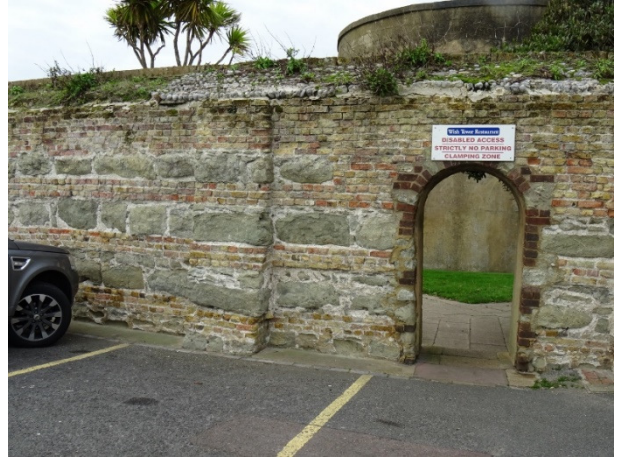
6.01 The south side of the perimeter glacis, or mound, forming a protective surround to the Tower has been removed, exposing the back of the retaining wall that was once supporting it. It is noted from Alan Dickinson's report that this was carried out in 1959. Given that the material forming the glacis is effectively excavated earth, it is anticipated that sulphates will have leached from the earth into the wall.

*South (external) face of southern glacis wall*

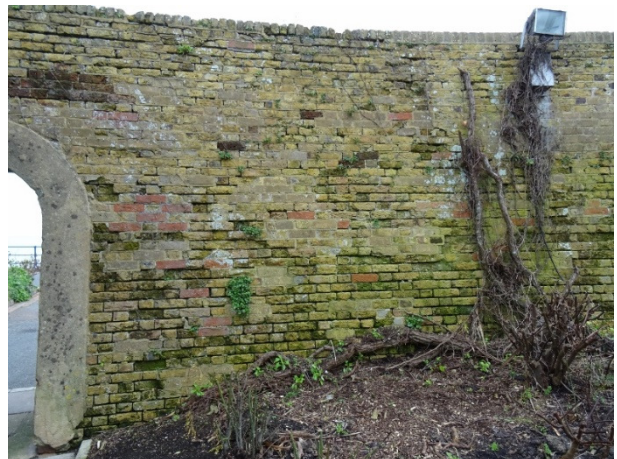
6.02 The retaining wall is constructed largely of yellow London stock clay bricks, laid to Flemish bond on the inside and, interestingly, laid to English bond on the outside. The outer face of the wall is interspersed with courses of Greensand, with intermittent piers. The piers are effectively vertical, whilst the wall itself has an outward batter to give enhanced resistance to lateral pressure from the soil behind. The wall is approximately 1100mm thick and where the south western end has been removed adjacent to the Wish Tower restaurant, it can be seen that the wall is of solidly laid bricks for its full thickness, rather than having loose rubble fill. It is therefore of substantial construction.

*North (internal) face of southern glacis wall showing brickwork erosion*

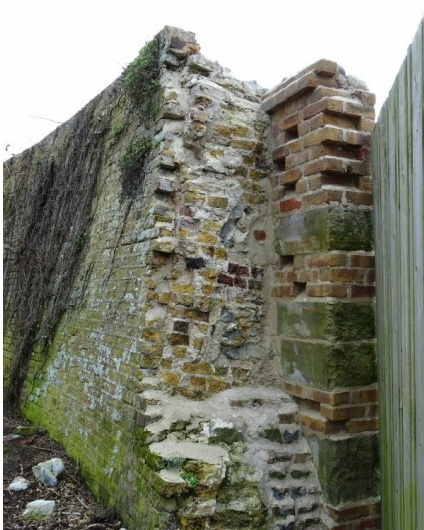
*Exposed section through glacis wall showing solid bonding*

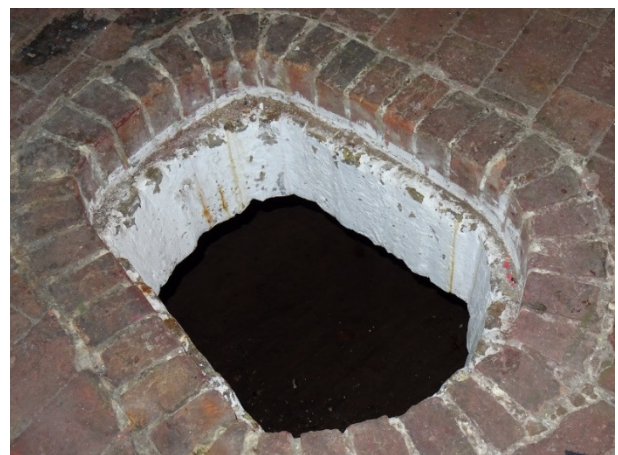
*Western access into cistern, with trap hatch removed*

partition dividing the store, hence the need for two separate accesses into the same cistern. The hatch on the east side is in a sound condition, whereas the west hatch is decayed and will need to be replaced.

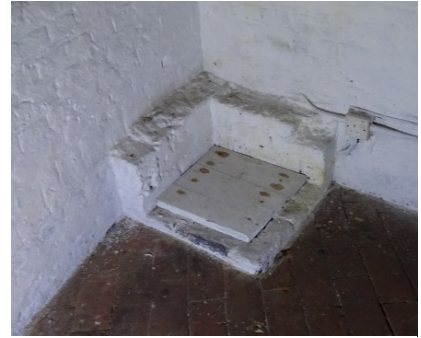
*Eastern sump into cistern,*

6.18 There are two sumps through the floor into the cistern below, that abut the perimeter walls to the magazine. The present timber covers to the sumps are of makeshift modern timber and will need to be replaced.

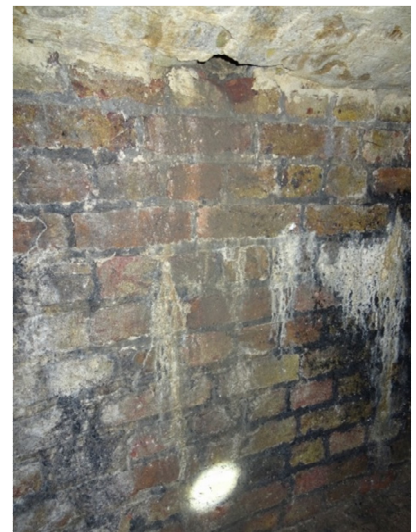
6.20 Sheila Sutcliffe refers to the possibility that Martello cisterns were replenished from either nearby wells, or from drainage pipes leading from the roof. It was observed within this cistern that, notwithstanding shallow puddles of water on the floor, no significant water had collected, despite recent heavy rainfall. Only one, fairly crudely formed opening in the perimeter brickwork was noted within the cistern, that could possibly lead to drainage from the roof but further investigation will be required to establish if and how this might work and whether it would be worth restoring.

*Point of potential water discharge from roof into cistern*

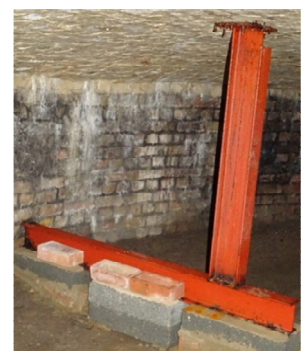
6.21 There is some modern steel strutting within the cistern beneath a steel spiral staircase between the store and the accommodation level. Whether this is structurally necessary will need to be determined.

*Modern steel strutting*

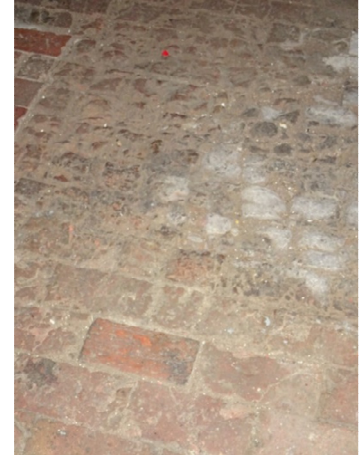
6.23 It was noted that there is a patch of surface damage to the brick floor in front of the inserted intake room. This will need repair but is considered to be generally cosmetic.

*Damaged area of brick floor,*

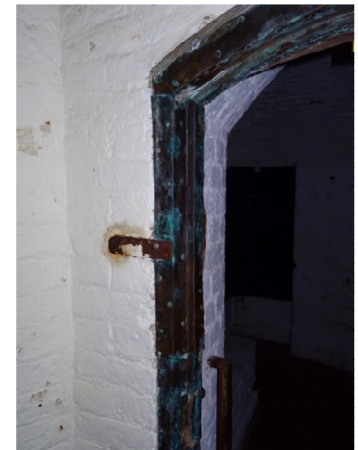
*Copper cladding to Magazine door frame*

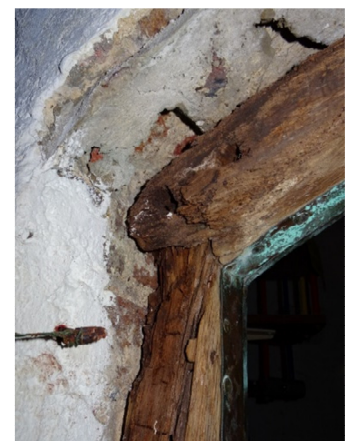
6.25 The most notable defect here is the condition of the door frame between the Magazine and the Store, which has almost completely disintegrated due to decay. The frame is clad with sheet copper, which is resistant to sparking. This feature is important in the describing the function of the building and must be retained. The timber frame, which appears to be of oak, is beyond repair and although a section of it could be retained for display, it will need to be replaced. Very careful attention will be required to ensure that its copper cladding is not damaged and will be retained on the new frame.

*Decayed condition of Magazine door frame*

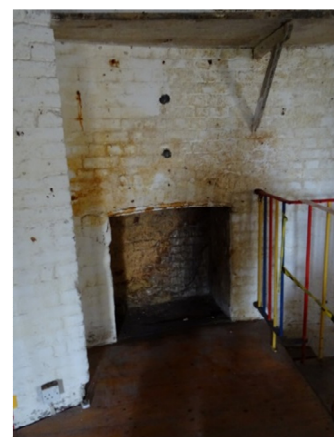
*Western chimney breast*

6.30 Further effects of damp were noted on the chimney breasts to both fireplaces, along with typical tar staining produced as a product of combustion. Dampness to these areas has

probably been exacerbated by the lack of ventilation through the blocked off flues and also from hygroscopic salts, absorbing moisture from the atmosphere.

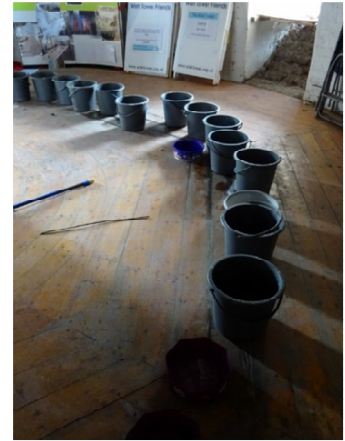
*Present drainage system!*

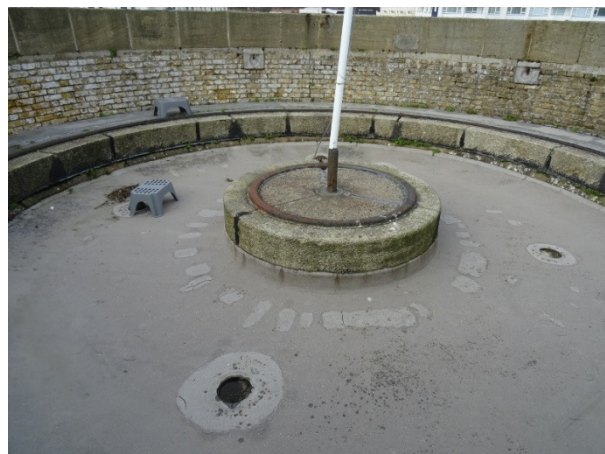
6.40 The problem at this level is with the condition of the asphalt covering within the gun well itself and around the perimeter. The asphalt contains many fractures and the condition of the drainage outlets is suspect. The upstand skirts to the asphalt are inadequate and have been supplemented with cement fillets in the past, which are also inadequate. Cracking and the growth of vegetation has added to the problems. There is no doubt that the poorly weathered roof covering has resulted in the majority of the water ingress through the brick vaulting below.

*General view of gun platform roof*

6.41 Sheila Sutcliffe describes the original roof covering as being of lead and consideration will need to be given as to whether a better detailed asphalt covering is provided, or if reinstating a new lead covering would provide a more appropriate and long-standing solution. Whichever is decided upon, it is essential that a new covering is provided. The present asphalt has deteriorated beyond the point where further patching would be feasible.

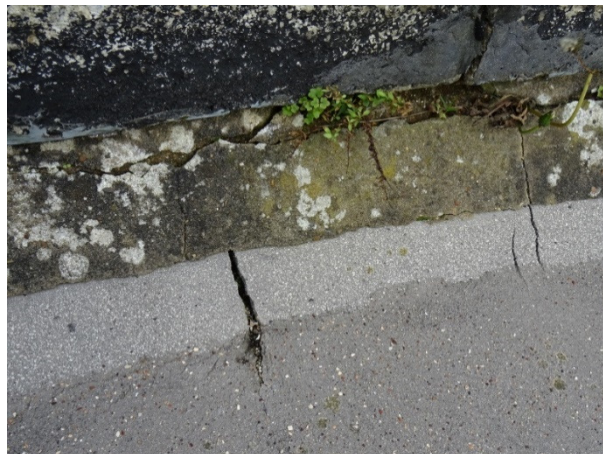
*Typical splitting to asphalt*
